Errata Documentation

Product	Part Number	Description	Status
PCI 9656BA	PCI9656-BA66BI	64-bit 66MHz PCI, 32-bit 66MHz Local, PBGA Package	Production Released

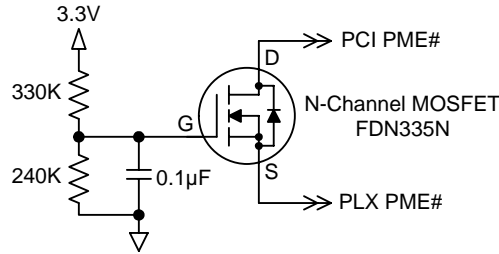
8. PME# Pin Isolation

Actual Behavior: The silicon does not ensure such protection and does present a low impedance path to ground when in the D3cold state, essentially causing an accidental wake up event every time the add-in card is inserted.

If PME# is to be implemented, an external FET must be inserted between the silicon's PME# signal pin and the PCI Slot. Suggested circuit:
